Abstract

Objectives

The aim of the project presented here was to develop a sensor that allows a more direct measurement of the integrity of grout in operational conditions.

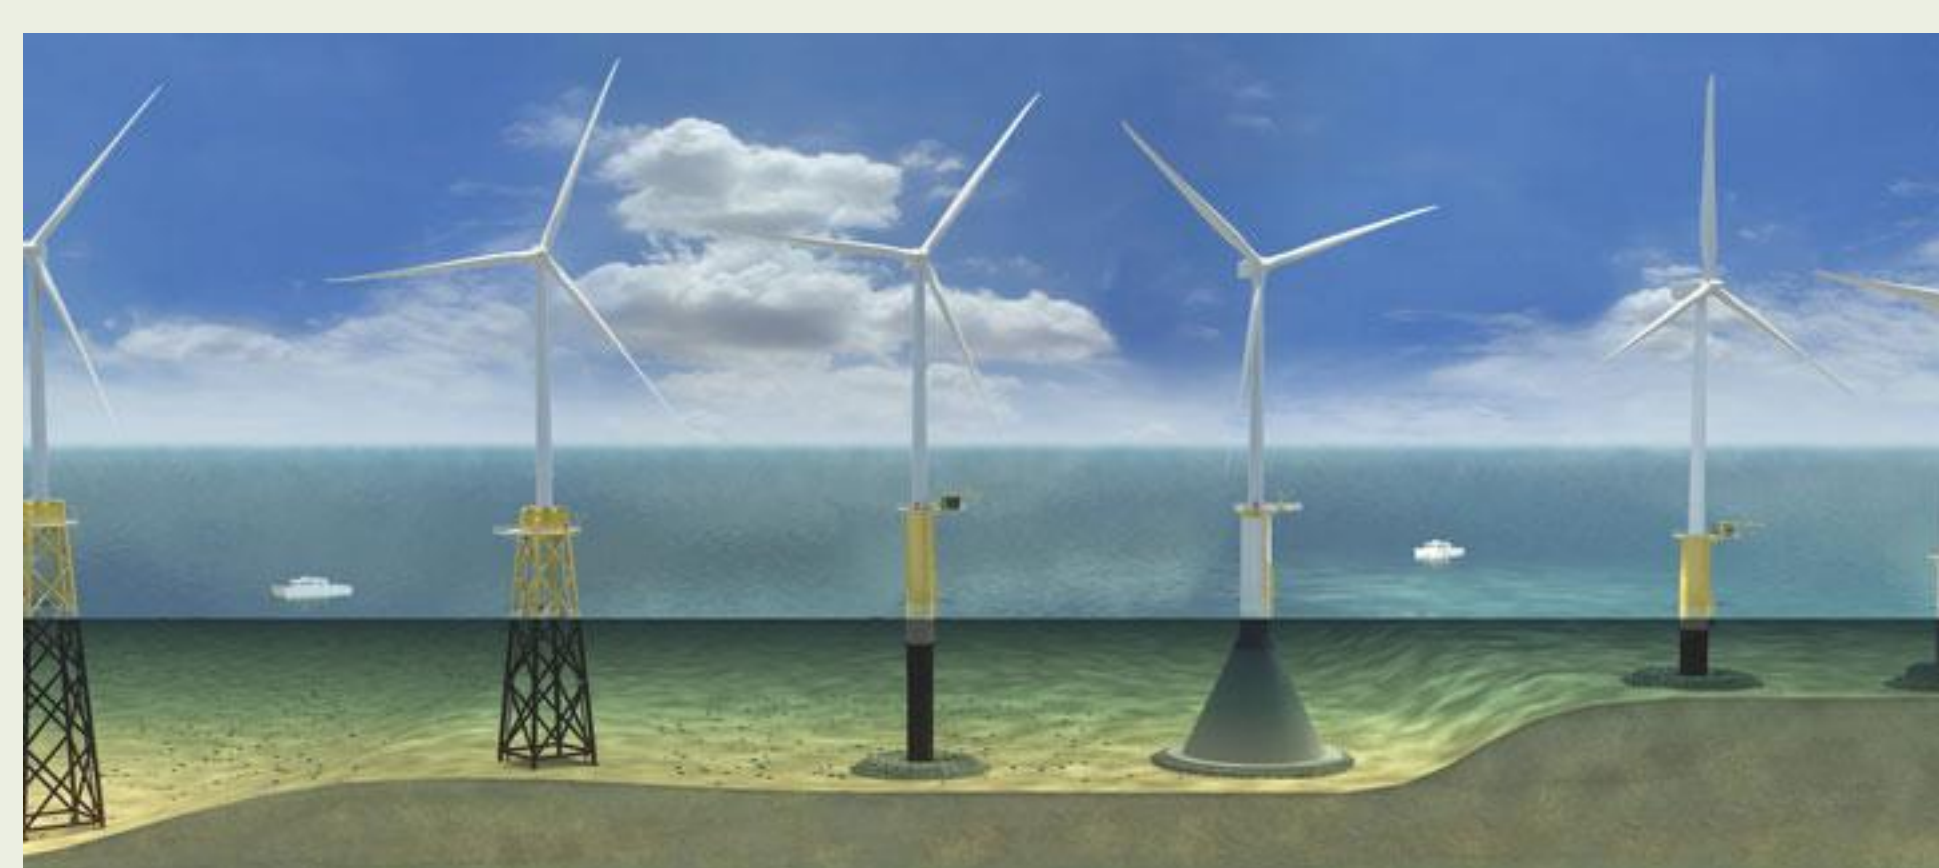
From [2]

Grout has been used as a construction material since about the very beginning of offshore wind construction. Examples are the grouted connections between monopile foundations and transition pieces as well as in fixing jacket foundations near the seabed [1]. As foundation structures are foreseen to support the wind turbines on top for at least the entire operational life foreseen, it is essential to be able to monitor their structural integrity in order to identify as early as possible potential structural defects. Monitoring schemes represent a powerful tool for the follow-up of structural integrity. The present paper presents a set of results obtained with a new, in-situ sensor designed to continuously monitor grout integrity in a monopile-type foundation.

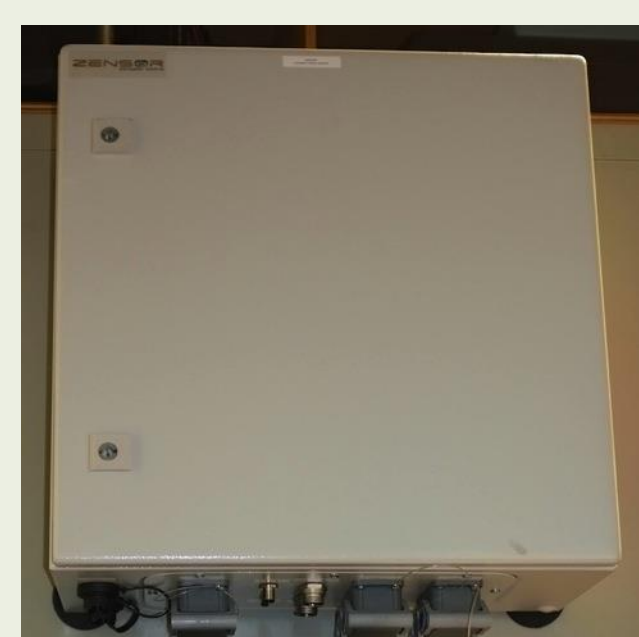
- Inert electrodes (Top picture and bottom scheme on the left: MMO coated Ti) are placed in the grout and connected to a central monitoring unit (center picture on the left). Placement (bottom 2 pictures) is done at grouting (or in retrofit in existing grouted connections after drilling installation holes).
- The monitoring unit applies a sinusoidal signal different frequencies
 - Between the electrode and the nearby steel structure (wall or rebar)
 - Between 2 neighboring electrodes
- From the system's response the monitoring unit calculates the conductivity
