Fatigue Failure Accident of wind turbine tower in Taikoyama Wind Power Plant

Yin LIU¹, Takeshi ISHIHARA²

^{1,2}Department of Civil Engineering, School of Engineering, the University of Tokyo, Tokyo, Japan

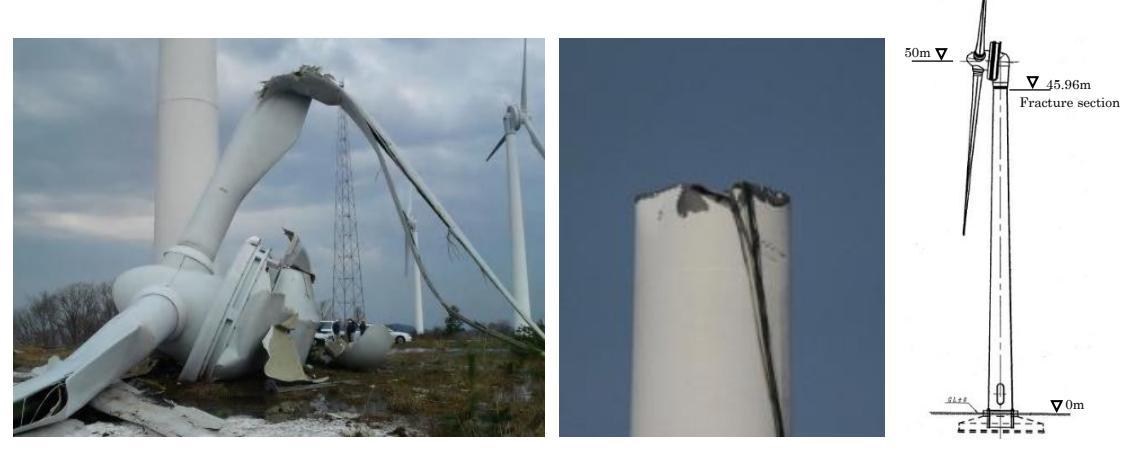
Fig.1 Accident scene and schematic diagram

(a) Collapsed nacelle (b) Fracture section

(c) Vertical cross section

By observing the fracture faces of the turbine tower tube, evidence of fatigue crack propagation was found at the inner side of the tube. Furthermore, broken bolts were found during the filed investigation. By comparing the two aspects, this failure is considered to be preceded by a certain degree of fatigue damage caused by the decrease of bolts pre-tension force.

For this Taikoyama wind turbine, the cause of the accident is not the matter of design or material, but it is because of the reduction of high tension bolts' pre-tension force;

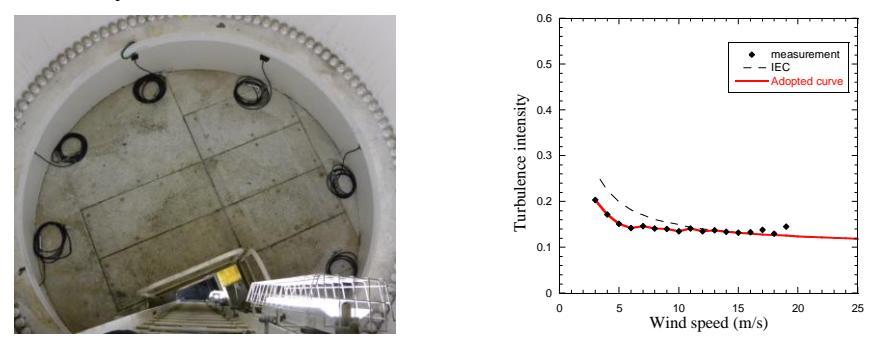
Fig.2 Schematic diagram of strain gauges installment

The tower base moment (height 12.6m) was measured by using strain gauges shown in Fig.2 to validate the aerodynamic model from Feb. 2nd 2015 to Feb. 28th 2015.

Fig.2 shows the bin averaged turbulence intensity derives from the measured result. In dynamic simulation, measured turbulence intensity was used for wind speed lower than 15m/s. For higher wind speed the turbulence intensity is extrapolated assuming the normal turbulence intensity in IEC 61400-1 ^[4]. The red line shows the turbulence intensity used in dynamic simulation.

Fig.3 Turbulence intensity vs. wind speed

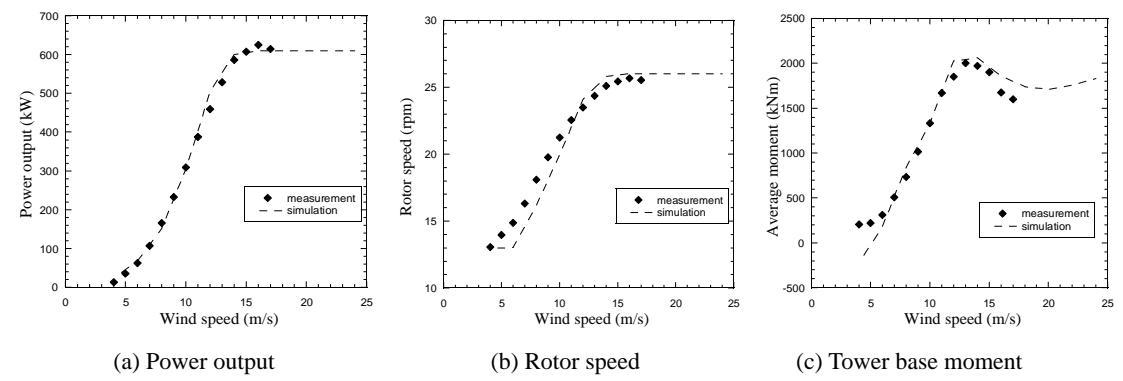
Fig.4 Comparison of the measurement and simulation result

Fig.4 shows the comparison of bin averaged power output, rotor speed and tower base moment by measurement and dynamic simulation. The figures show good agreement with the measurement results.

1) The power output, rotor speed and tower base bending moment are calculated from dynamic simulation which are in good agreement with measurement results;

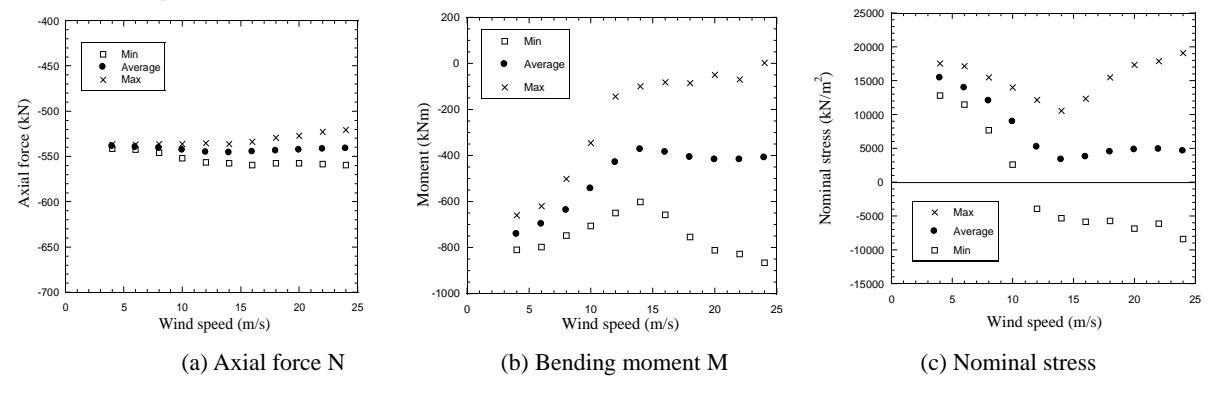
Fig. 5 (a) and Fig.5 (b) show the calculated values of axial force N and bending moment M at the fracture section of different wind speed from the dynamic simulation.

The axial force and bending moment obtained from the aerodynamic simulation are used to calculate the nominal

stress through $\sigma = \frac{N}{A} - \frac{M}{Z}$, in which A represents the sectional area and Z represents the sectional resistance moment.

The nominal stress for different wind speed is shown in Fig.5 (c). The stress range increases significantly with the increase of the wind speed. The minimum stress turns into negative value when the wind speed is higher than 11 m/s.

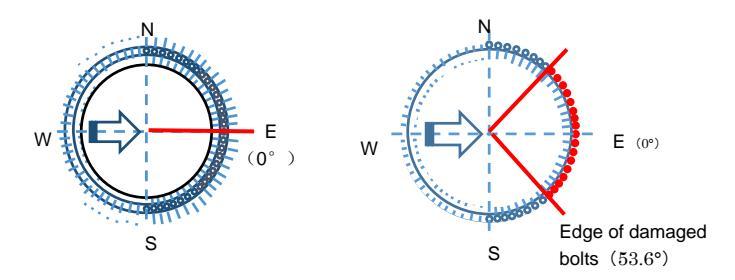
Fig.6 Diagram of the damage area

A 3 Dimensional FE model is developed to calculate the local stress at the fracture section before and after the bolts damaged. Fig.6 illustrates the difference before and after the bolts' damage.

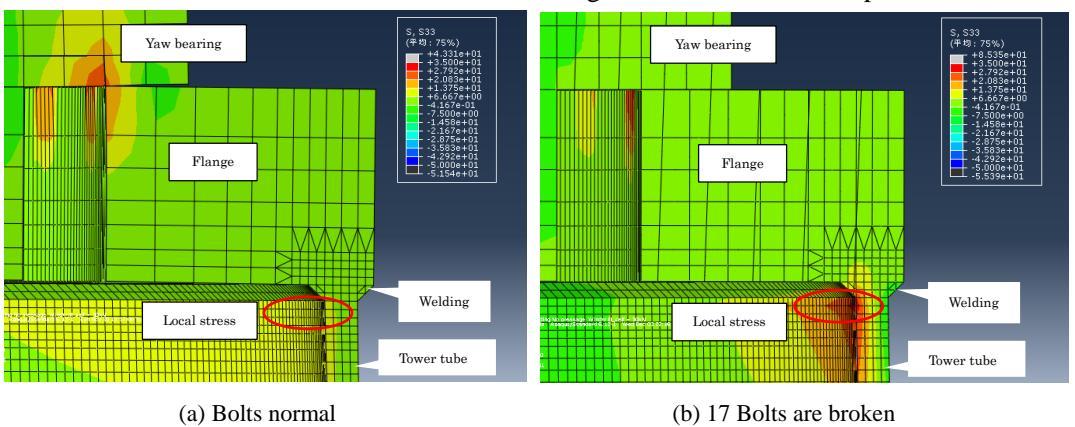
Fig.7 Comparison of the local stress from FE model (wind speed is 16m/s)

To simulate the condition of wind speed, different thrust force at hub height is used. Fig.7 compares the local stress at the fracture section before and after the bolts are damaged in the case of wind speed is 16m/s.

Fig.7 (a) implies the cause of maximum tensile stress happens at the inner tube is because of the lever principle, which is consistent with the observation of fracture face. According to Fig.7 (b), the local stress is larger when 17 bolts are broken.

2) With 17 bolts broken the local stress at tower top increases three times, which accelerated the fatigue initiation and propagation;

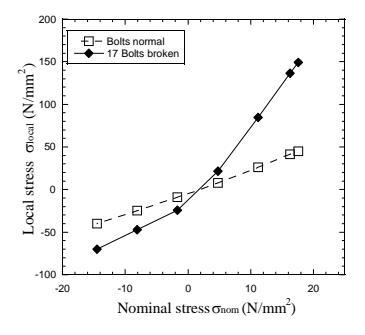
Fig.8 Local stress vs. nominal stress

Fig.8 shows the relationship between local stress and nominal stress. The nonlinear phenomenon happens when 17 bolts are broken. The local stress with 17 bolts broken is more than three times of the local stress when bolts are normal.

Combined with Goodman formula, rain-flow counting method, the relationship between local stress and nominal stress shown in Fig.8 and S-N curve^[5], the cumulative fatigue damage and fatigue life in 20 years is evaluated and listed in Table 1. Frequency distribution of the wind speed is based on on Rayleigh distribution with the mean wind speed of 8.5m/s. When the bolts are in normal condition the fatigue life is 21 years, which is consistent with the design requirement. However, if 17bolts broken, the fatigue life decreases dramatically to 0.25 years, which is approximately three months.
